Comstock Estates
Fruita, CO

Report #: 48057-0
Beginning: January 1, 2026
Expires: December 31, 2026

RESERVE STUDY
"Full"

August 11, 2025

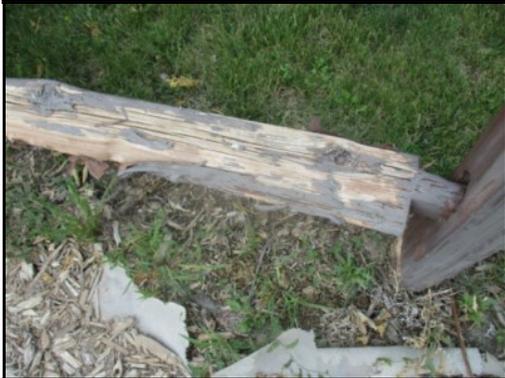
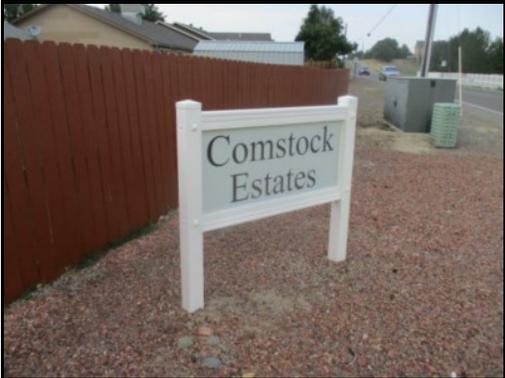
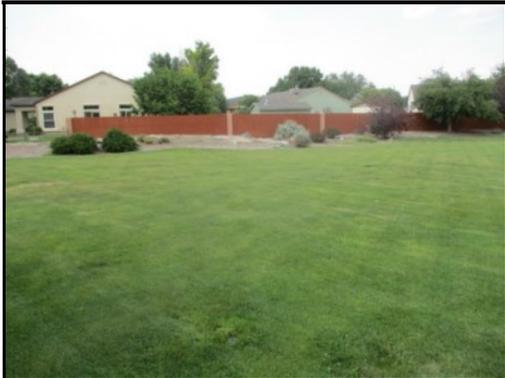
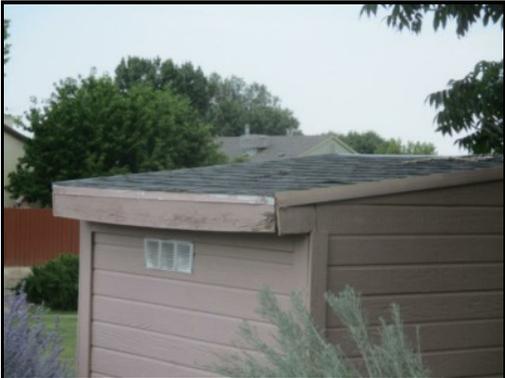
During our site visit on 7/16/2025 we visually inspected the common area assets and were able to see a majority of the common areas. Please see photo appendix for component details; the basis of our assumptions.

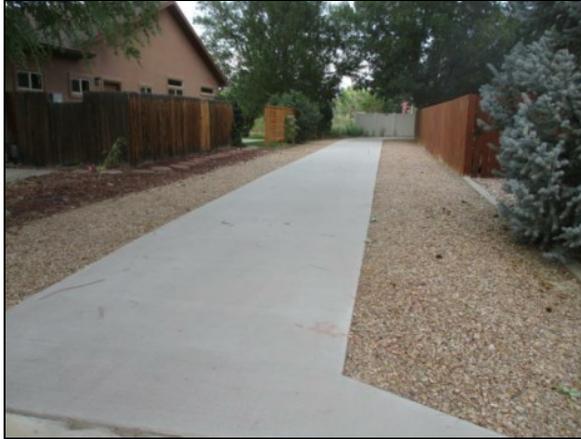
Comp #: 21090 Concrete Walkways - Replace - 5%

Comments: Concrete sidewalks determined to be in fair condition typically exhibit minor changes in slope and a moderate percentage of cracking and surface wear. Trip hazards may be increasing in frequency and severity and should be closely monitored to prevent further risks. The Rocky Mountain Region is home to expansive soils. One of the causes of concrete damage in this type of climate is soil moisture. Expansive soils tend to swell in size when wet and contract as they dry out. As the soil expands and contracts it can create enough force to cause major damage to sidewalks. Repair any trip and fall hazards immediately to ensure safety. As routine maintenance inspect regularly pressure wash for appearance and repair promptly as needed to prevent water penetrating into the base and causing further damage. In our experience larger repair/replacement expenses emerge as the community ages. Although difficult to predict timing cost and scope we suggest a rotating funding allowance to supplement the operating/maintenance budget for periodic larger repairs. Adjust as conditions actual expense patterns dictate within future reserve study updates.

0 years

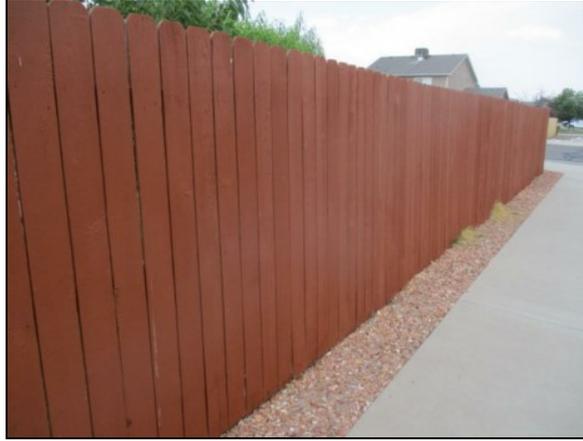
Comp #: 21320 Site Fencing: Wood - Repair/Paint

Comments: Includes both 6' privacy fence and rail fencing. Wood fencing determined to be in fair condition typically exhibits a finish coat which is mostly uniform but exhibits minor to moderate surface wear or fading possibly exposing wood substrate in some areas. Regular uniform professional paint or sealer applications are recommended for appearance protection of wood and maximum design life. Repair as needed and clean prior to application. Plan for regular applications as shown below. Timing of repair/paint cycles may need to be coordinated with eventual fence replacement.

Useful Life:
5 years

Remaining Life:
7 years

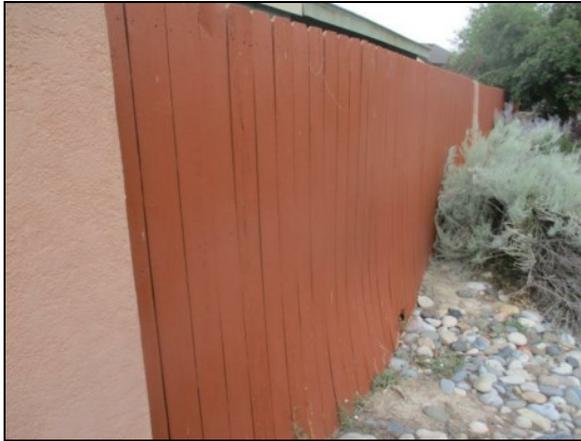
Comp #: 21330 Site Fencing: Wood - Replace

Comments: Wood fencing determined to be in poor condition typically exhibits more advanced or extensive surface wear and other signs of age which may include damaged or vandalized sections loose or missing hardware and other obvious concerns. At this stage fencing is often an eyesore and replacement from an aesthetic standpoint should be considered even if fencing is still technically upright and intact. As routine maintenance inspect regularly for any damage repair as needed and avoid contact with ground and surrounding vegetation wherever possible. Regular cycles of uniform professional sealing/painting will help to maintain appearance and maximize life. In our experience wood fencing will typically eventually break down due to a combination of sun and weather exposure which is sometimes exacerbated by other factors such as irrigation overspray abuse and lack of preventive maintenance. Recommendation and costs shown here are based on replacement with similar style and material. However the client might want to consider replacing with more sturdy lower-maintenance products like composite vinyl etc. Although installation costs are higher total life cycle cost is lower due to less maintenance and longer design life expectancy.

2 years

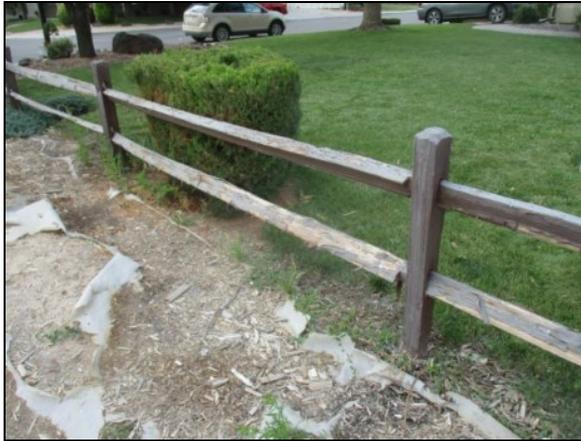
Comp #: 21340 Site Fencing: Wood Rail - Replace

Comments: Wood fencing determined to be in poor condition typically exhibits more advanced or extensive surface wear and other signs of age which may include damaged or vandalized sections loose or missing hardware and other obvious concerns. At this stage fencing is often an eyesore and replacement from an aesthetic standpoint should be considered even if fencing is still technically upright and intact. As routine maintenance inspect regularly for any damage repair as needed and avoid contact with ground and surrounding vegetation wherever possible. Regular cycles of uniform professional sealing/painting will help to maintain appearance and maximize life. In our experience wood fencing will typically eventually break down due to a combination of sun and weather exposure which is sometimes exacerbated by other factors such as irrigation overspray abuse and lack of preventive maintenance. Recommendation and costs shown here are based on replacement with similar style and material. However the client might want to consider replacing with more sturdy lower-maintenance products like composite vinyl etc. Although installation costs are higher total life cycle cost is lower due to less maintenance and longer design life expectancy.

7 years

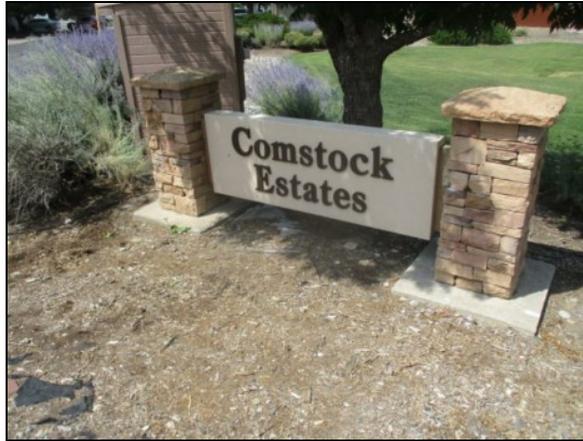
Comments: Monument signage determined to be in fair condition typically exhibits acceptable appearance and aesthetics in keeping with local area but with more weathering and wear showing on surfaces. If present landscaping and lighting are still in serviceable condition. At this stage signage may be becoming more dated and diminishing in appeal. As routine maintenance inspect regularly clean/touch-up and repair as an Operating expense. Plan to refurbish or replace at the interval below. Timing and scope of refurbishing or replacement projects is subjective but should always be scheduled in order to maintain good curb appeal. In our experience most clients choose to refurbish or replace signage periodically in order to maintain good appearance and aesthetics in keeping with local area often before signage is in poor physical condition. If present concrete walls are expected to be painted and repaired as part of refurbishing but not fully replaced unless otherwise noted. Costs can vary significantly depending on style/type desired and may include additional costs for design work landscaping lighting water features etc. Reserve Study updates should incorporate any estimates or information collected regarding potential projects.

7 years

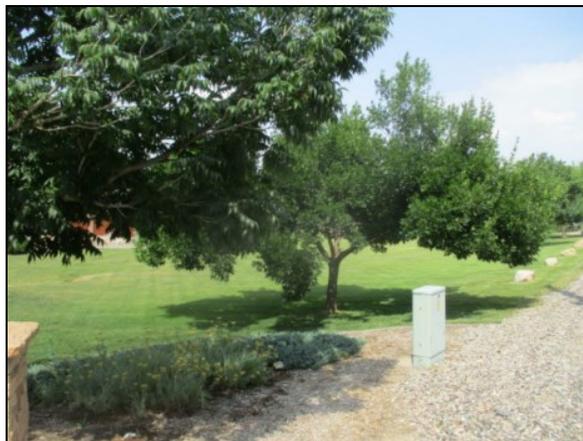
Comments: Routine tree trimming is expected to be included within the client's landscaping contract or otherwise reflected in the annual Operating budget. No need for Reserve funding at this time. If a pattern of larger expenses develops, or if substantial removal or replacement becomes necessary, the Reserve Study should be updated to incorporate new information. In this case, many clients choose to work with a qualified arborist or other landscaping professional to develop appropriate guidelines and scope of work.

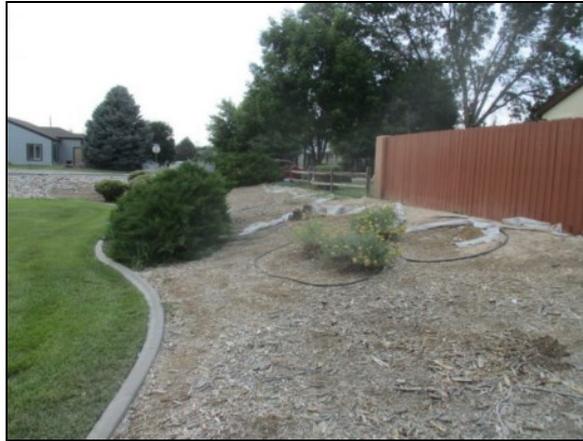
Comments: In general, costs related to this component are expected to be included in the client's Operating budget. No recommendation for Reserve funding at this time. However, any repair and maintenance or other related expenditures should be tracked, and this component should be re-evaluated during future Reserve Study updates based on most recent information and data available at that time. If deemed appropriate for Reserve funding, component can be included in the funding plan at that time.

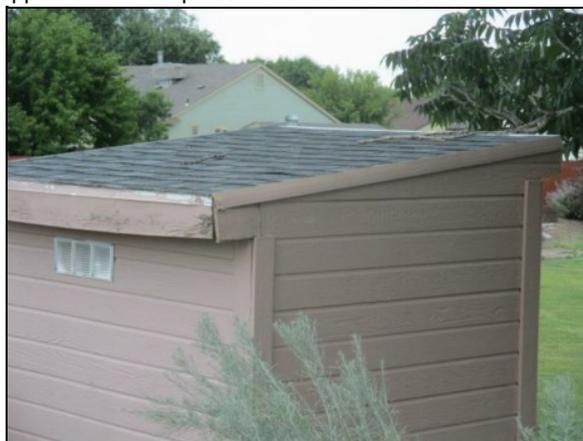
Comments: Pump houses determined to be in older condition typically exhibit normal signs of wear and tear, and curb appeal may be affected at this stage. All building envelope and mechanical components are believed to be in serviceable condition. If present, interior furnishings may be dated or inadequate. This component represents an allowance for maintaining the pump house. Pump house should be inspected, cleaned and small maintenance projects made as an Operating expense. Typical Reserve-funded projects may include: exterior painting, roof repairs/replacement, new windows and doors, lighting, signage, air conditioning, plumbing or electrical repairs, etc. For smaller pumphouses, any single project may not individually meet the threshold for Reserve funding, but combinations of projects done together may become significant. Pump houses have significant aesthetic value in terms of curb appeal and first impressions and should be maintained to a high standard.

Useful Life:
20 years

Remaining Life:
0 years

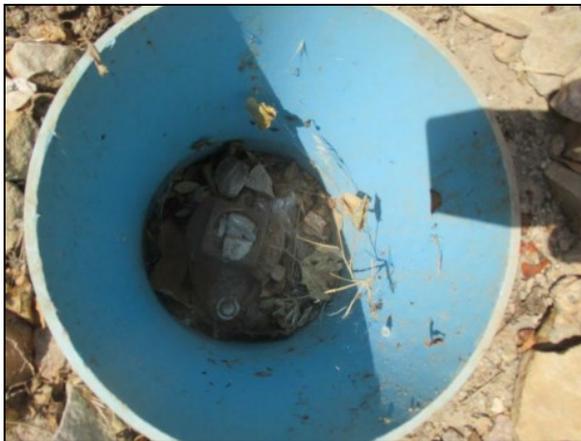
Comp #: 25280 Irrigation Valves - Replace

Comments: Minimal or no subjective/aesthetic value for this component. Useful life is based primarily on normal expectations for service/performance life in this location. Unless otherwise noted remaining useful life expectancy is based primarily on original installation or last replacement/purchase date our experience with similar systems/components and assuming normal amount of usage and good preventive maintenance.

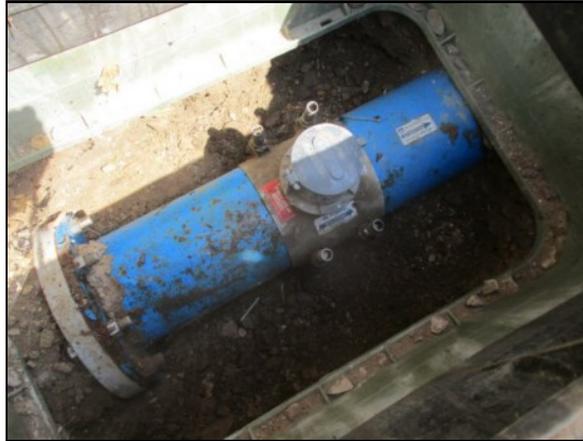
Comp #: 25290 Entry Valve - Replace

Minimal or no subjective/aesthetic value for this component. Useful life is based primarily on normal expectations for service/performance life in this location. Unless otherwise noted remaining useful life expectancy is based primarily on original installation or last replacement/purchase date our experience with similar systems/components and assuming normal amount of usage and good preventive maintenance. No access to see pumps closely. Costs based on input from building/management staff and/or experience with similar installations. Sump pump systems can have a highly variable life expectancy depending on level of use. Should be inspected regularly and repaired as-needed by servicing vendor or maintenance staff to ensure proper function and optimal performance.

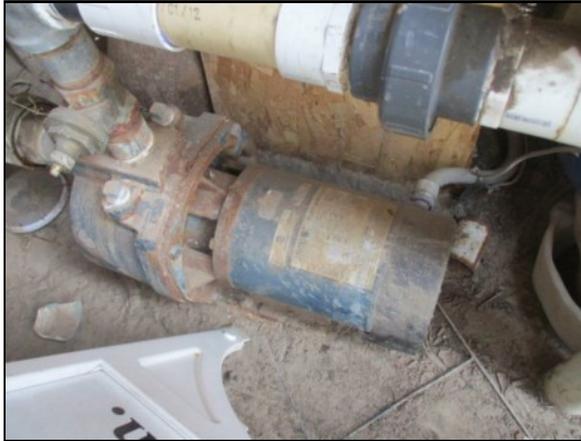
Comp #: 25560 Irrigation Pump – Repair/Replace

Comments: Minimal or no subjective/aesthetic value for this component. Useful life is based primarily on normal expectations for service/performance life in this location. Unless otherwise noted remaining useful life expectancy is based primarily on original installation or last replacement/purchase date our experience with similar systems/components and assuming normal amount of usage and good preventive maintenance. Irrigation pump(s) can often be repaired or rebuilt rather than completely replaced. Motor rebuilds and other repairs are often considered an Operating expense. Pumps and motors need to be checked and serviced regularly by landscaping/irrigation vendor or other maintenance personnel to ensure proper function. If possible equipment should be protected from sunlight and weather to minimize exposure and prolong life. Costs to replace are based on similar size and horsepower. If there is more than one pump in place cost ranges shown below are based on complete replacement of all pumps at one time usually based on similar/same age and expectation of comparable life expectancy.

0 years

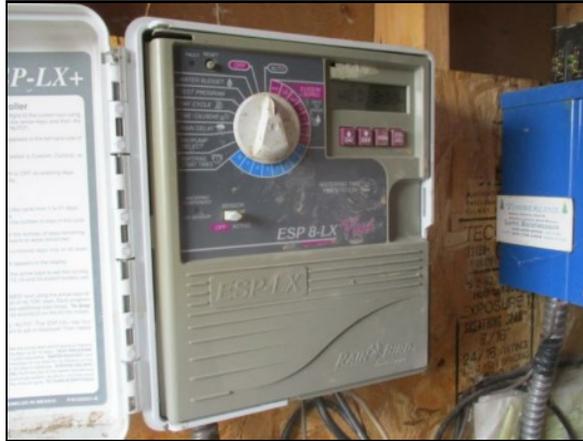
Comp #: 25570 Irrigation Clock - Replace

Comments: Minimal or no subjective/aesthetic value for this component. Useful life is based primarily on normal expectations for service/performance life in this location. Unless otherwise noted remaining useful life expectancy is based primarily on original installation or last replacement/purchase date our experience with similar systems/components and assuming normal amount of usage and good preventive maintenance. Irrigation controllers should have a relatively long life expectancy under normal circumstances. Replacement is often required due to lack of available replacement parts lightning strikes etc. as opposed to complete failure of existing equipment. Exposure to the elements can affect overall life expectancy and controllers should be located in protected areas or within protective enclosures whenever possible. When evaluating replacement options the client should consider replacement with smart" models (i.e. respond to projected weather data) to minimize unnecessary water usage. Payback period for efficient controllers that minimize water use is typically very short

Useful Life:
15 years

Remaining Life:
0 years
